South Fork Saline River near Carrier Mills, IL

Study Reach.--The channel reach under consideration is a dredged channel with heavy vegetation coverage. The study reach selected, approximately 750 ft long, is located from 400 ft upstream of the USGS streamgage-station to 350 ft downstream of the station. The study reach represents a transition from a straightened dredged channel to a natural meandering channel segment downstream, as shown in the quadrangle map on the top left. Five surveyed cross sections (surveyed by the U.S. Geological Survey in April 2003) are available for evaluating channel geometries of the study reach. The channel alignment and approximate variations in channel width and bank conditions are shown in the aerial photo on the top right. Cross-sectional geometries vary gradually and continuously from upstream to downstream (see plots above).

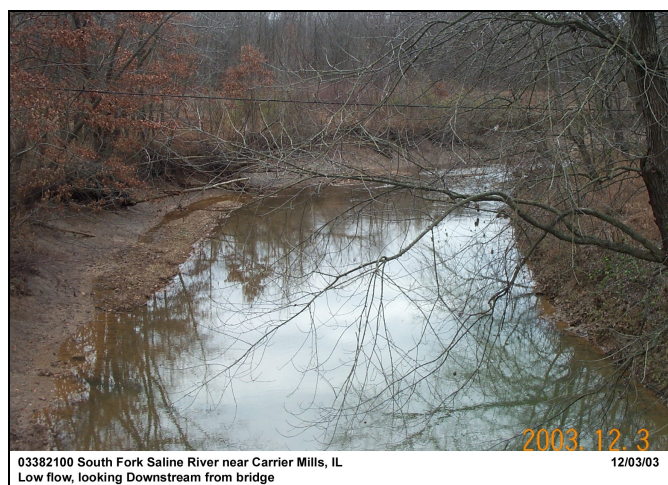
03382100 South Fork Saline River near Carrier Mills, IL.
Looking Downstream

Description of Channel.--This channel is natural with a 90° bend. The bend represents a transition from a straightened dredged channel to a natural meandering channel. The bed materials consist of hard clay and shale overlain in spots with fine sediments from strip mining upstream. Channel geometry is generally trapezoidal with bed encroachment showing at upstream portion of the study reach. The bottom width of the channel widens from about 40 ft upstream to as much as 60 ft downstream. The left-bank height is about 14 ft and right bank height is approximately 10 ft before any overflow to the flood plains occurs. Top width of the channel ranges from about 50 ft to nearly 70 ft. Bank faces are covered with grasses and exposed tree roots. The top of the right bank is wooded and brushy along the channel, with grass in the flood plains. The left flood plain is a cultivated field. Bank slope is steep and both banks are eroded up to the tree line.

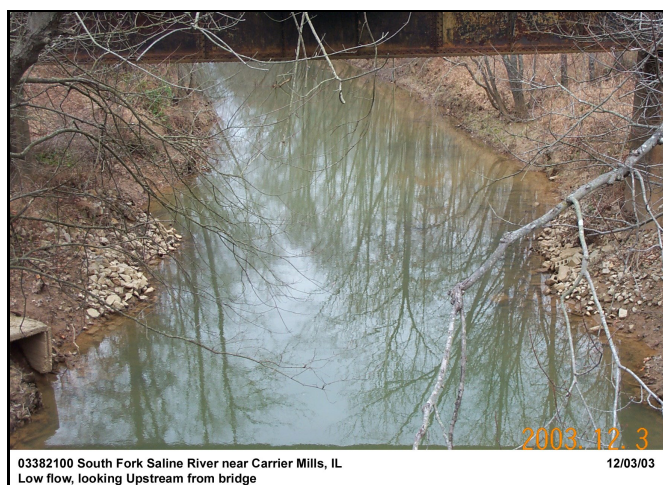
0382100 South Fork Saline River near Carrier Mills, IL.
Looking Upstream
